4. TITLE (and Subtitle) <b>National Program of Inspection of Non-Federal Dams Tennessee. Kagley Dam (Inventory Number TN 00908) near Wellsville, Tennessee, Blount County, TN., Little Tennessee River Basin</b>		5. TYPE OF REPORT & PERIOD COVERED <b>Phase 1 Investigation Report</b>

PHASE I INSPECTION REPORT  
NATIONAL DAM SAFETY PROGRAM

Name of Dam ..... Kagley  
County ..... Blount  
Stream ..... Unnamed Trib. of  
Sixmile Creek  
Date of Inspection ..... May 19, 1981

PHASE I INSPECTION REPORT  
NATIONAL DAM SAFETY PROGRAM  
KAGLEY DAM  
BLOUNT COUNTY, TENNESSEE

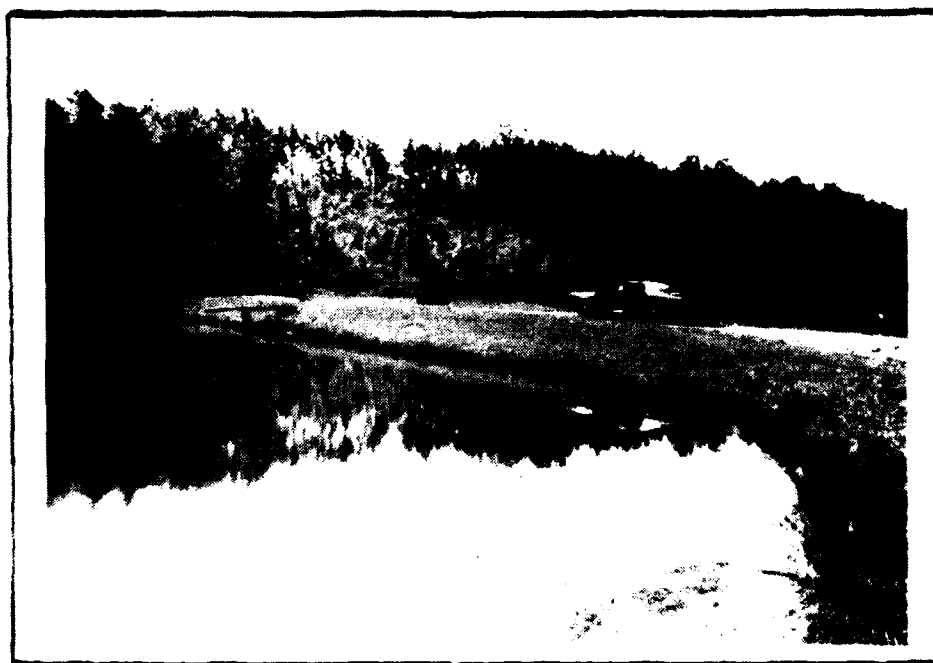
PHOTO NO.2

- 3.1.1 Embankment - The upstream slope above the water surface was found to have a good cover of well maintained grass on a fairly uniform, continuous grade of 1V:3.4H (photo 2). The grass cover serves as slope protection from surface runoff with no erosion of the grassed face detected. However, there is no slope protection at the water line and minor sloughing from erosion is occurring along the entire water line resulting in a slight benching below the water surface. No signs of structural instability were found.

A gravel and asphalt road covers the entire crest with a width of 12 feet (photo 2). The road is in good condition and serves as access for a single dwelling. The crest is linearly aligned and is roughly 170 feet long. Along the crest and towards the right end of the dam, there is a decline in elevation with a noticeable drop, roughly 1 foot, in the area of the right abutment where the emergency spillway is located (photo 9).

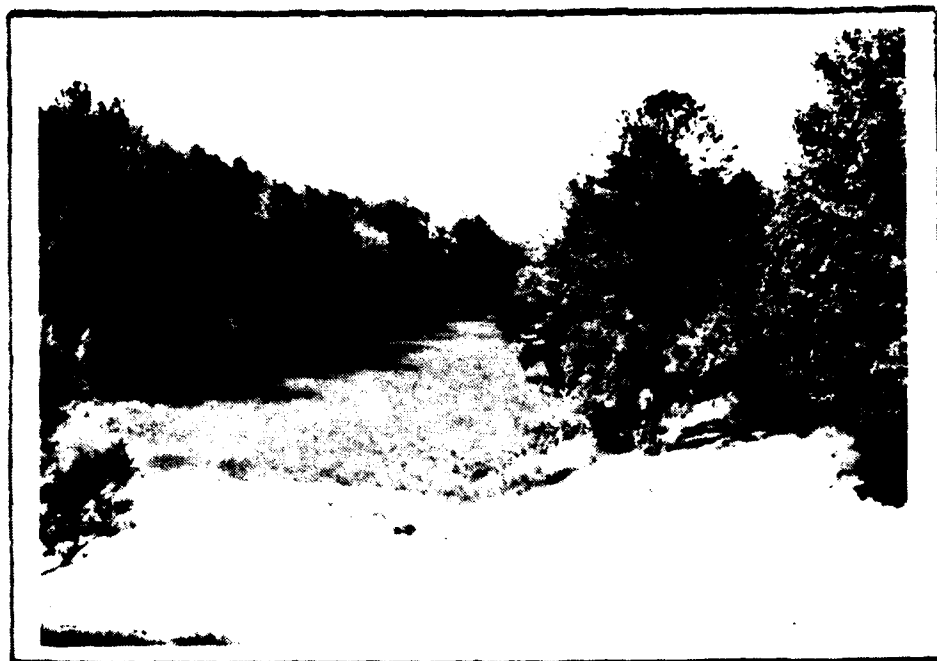
PHOTO NO.3

The downstream face has a gradual transition with each abutment giving the appearance of a "bowl" shape. The downstream slope was found to have a good cover of well maintained grass on a fairly uniform continuous grade of 1V:3.5H (photo 3). There are three 4 inch diameter pine trees evenly spaced on the slope a few feet below the crest (photo 4). Near the middle of the dam and approximately halfway down the slope a soft area, roughly 5' X 20', was observed with wetland vegetation (photos 10 & 11). A rut roughly 10 feet long and 3 inches deep was located down from the soft area near the toe (photos 10 & 11). There was no evidence of seepage from either area.

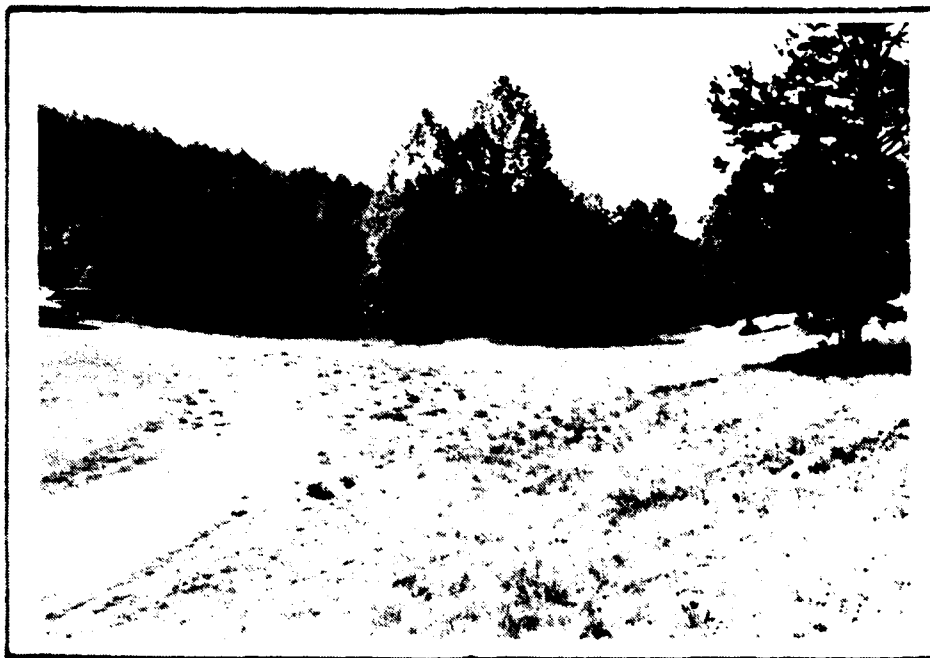
PHOTO NO.9

end of the dam at the emergency spillway interface (photo no. 9; Figure 4). The upstream face is generally sloped at 3.4H:1V from the crest to the water surface where a small bench has formed from slight wave erosion. The downstream face is generally sloped at 3.5H:1V uniformly across the embankment. All slopes are covered with well maintained grass.

- Photo No. 8 - Water supply pipe outlet. Note crack in  
valve.
- Photo No. 9 - Emergency spillway at right abutment.
- Photo No. 10 - View from the toe locating soft area near  
inspector, erosion rut, and hole.
